USAALABS TECHNICAL REPORT 70-53

TURBINE BLADE/DISK FABRICATION INVESTIGATION

CONTRACT DAAJ02-68-C-0071 *NEW*

PRATT & WHITNEY AIRCRAFT

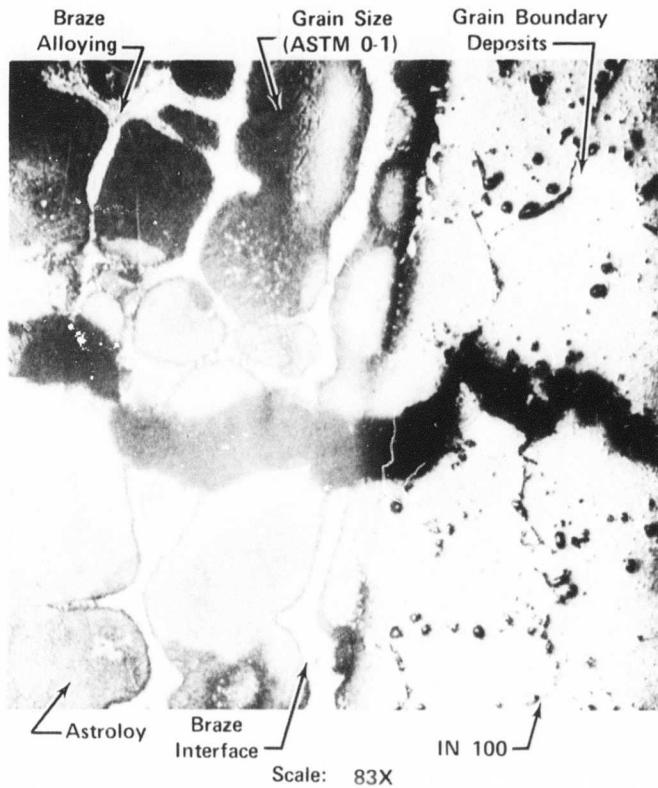
Figure 105. Photomicrograph of Braze Joint (Specimen SN 218).
